Downers Grove

# Inflow and Infiltration Removal

# Downers Grove Sanitary District Background

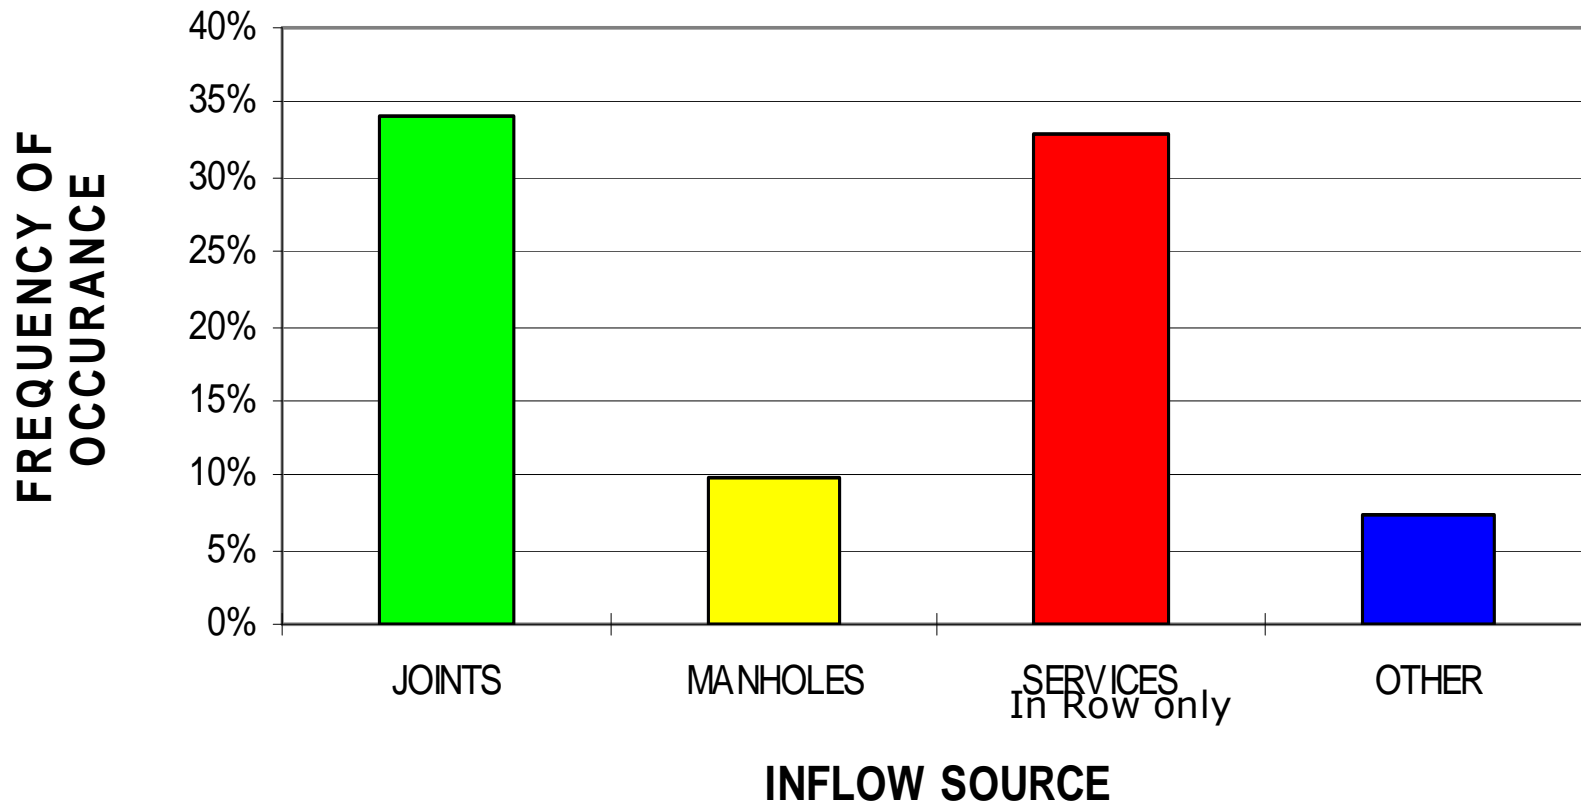
**EXHIBIT 3**

**Downers Grove Sanitary District  
1997 Dyed Water Flood Testing**

**Mainline Sewer Testing - Inflow Source Summary**

- Continuing SSES in late 1980s and 1990s (Flood Testing)
  - 1997 Flood Testing
    - 102 setups, approx 30,000 LF of sewer
    - Identified 1600 gpm of I/I
    - 90% of defects were joints, manholes and services (infiltration)
    - Only 3 sections with I/I greater than 100 gpm
  - 1998 Flood Testing
    - 25 setups, approx 7,500 LF of sewer
    - Only 98 gpm of I/I identified
  - 1999 Flood Testing
    - 23 setups, approx 7,000 LF of sewer
    - Only 1100 gpm of I/I identified

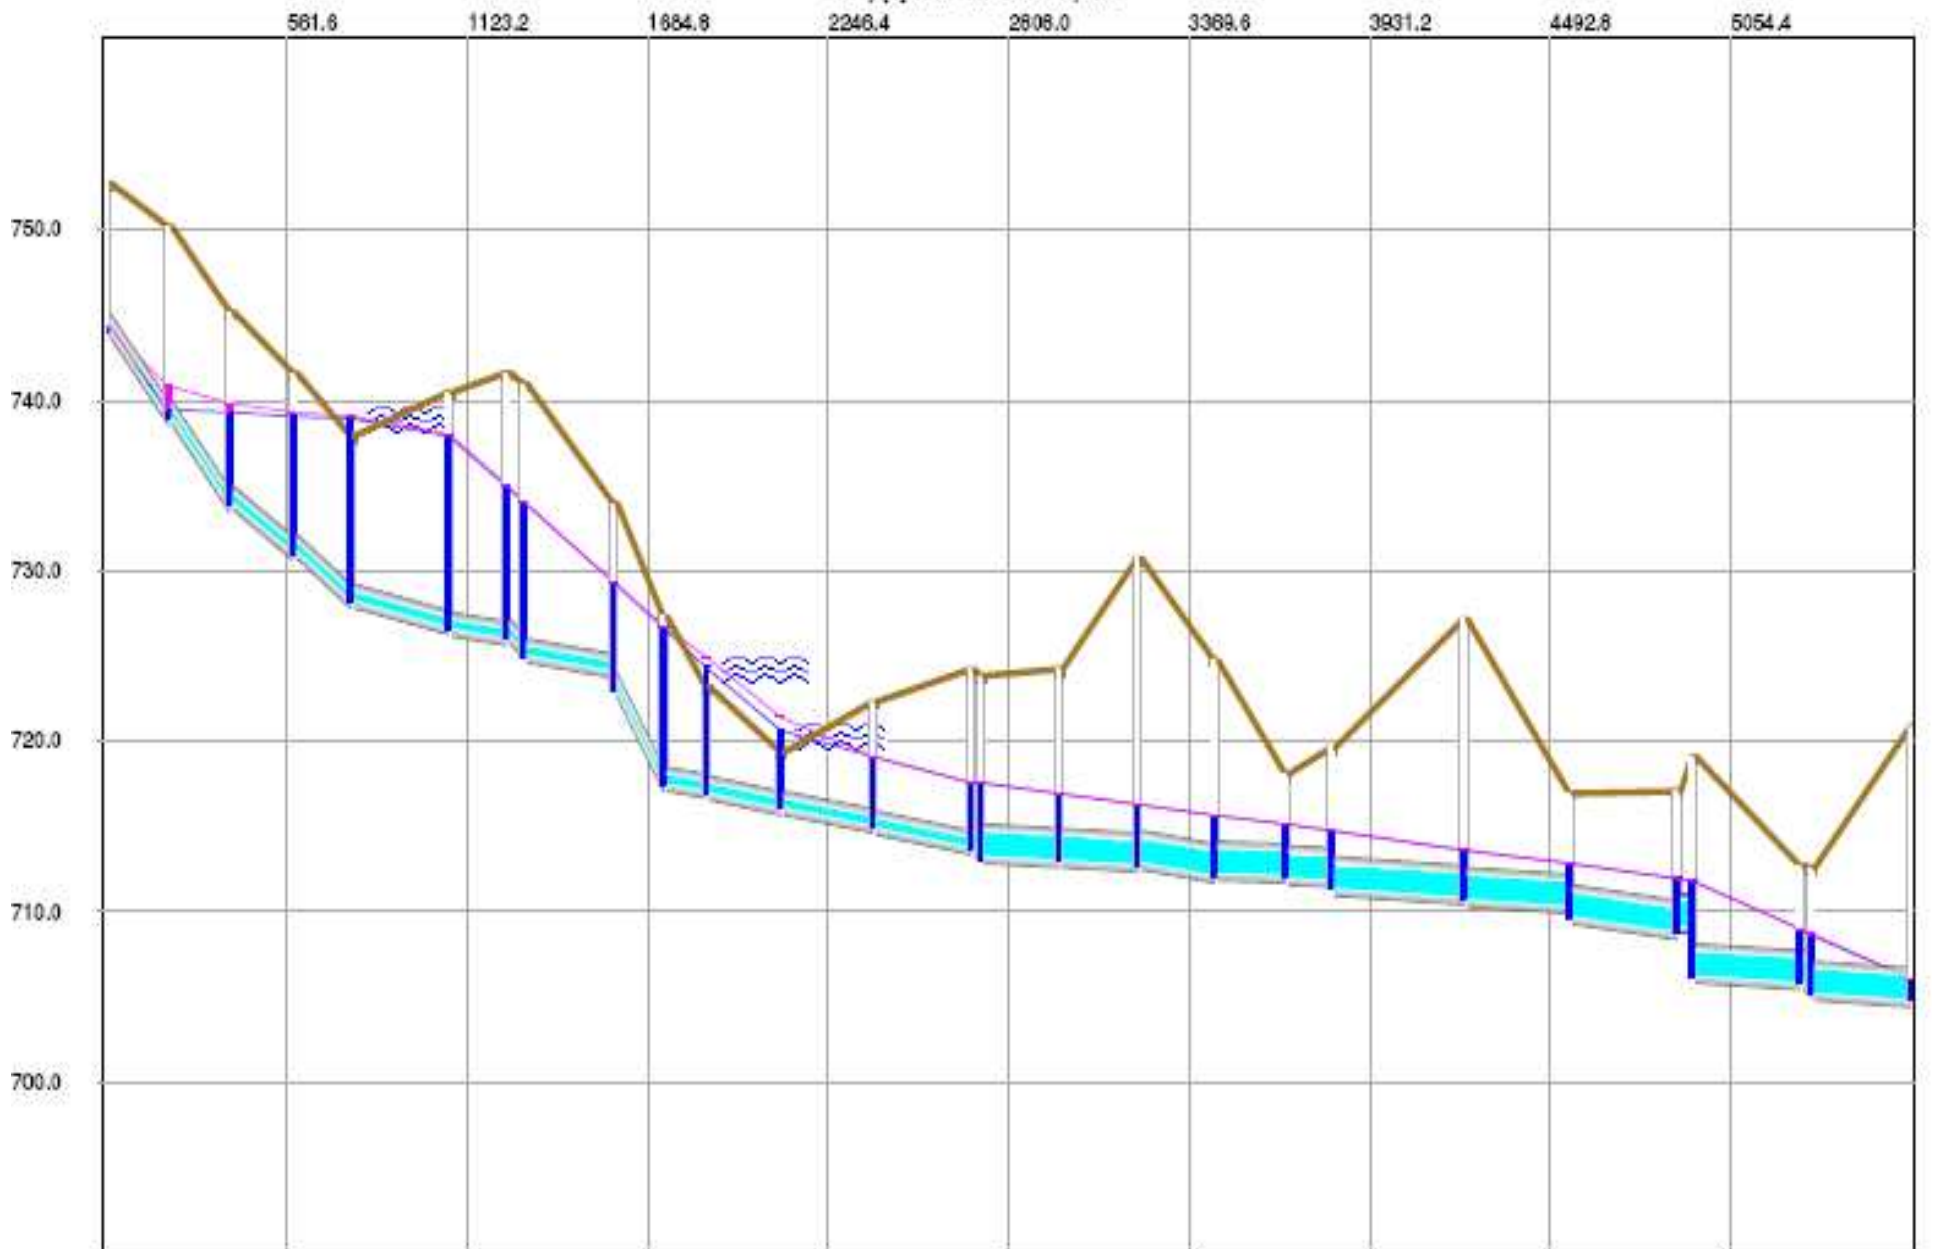
DGSD - 10-Year Event - Reach 1 Exhibit 2

- Hydraulic Analysis Report
  - XP-SWMM Model
  - System Capacity = 512 gpm
  - Alternatives to eliminate overflow
    - Increase Capacity
    - Boltdown Covers
    - Increase Capacity and boltdown
    - I/I Removal
  - 45% - 75% I/I Removal required
  - Select I/I Removal Alternative

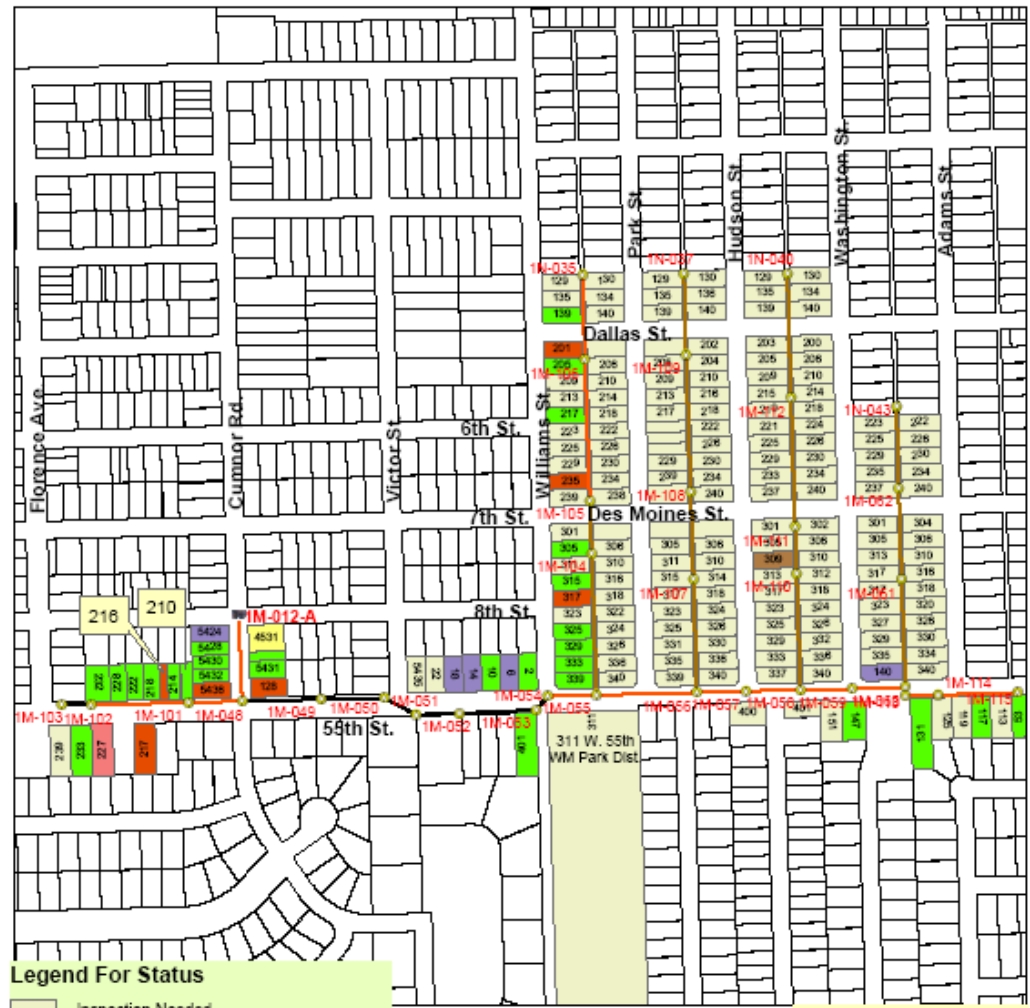
# Downers Grove Sanitary District 1M-012-A Rehabilitation Area Status 4/4/2007

- I-M-12A Rehabilitation Schedule
  - Manhole Inspections – Complete
  - Sewer Televising – Complete
  - Survey work – Complete
  - House inspections
    - 90% complete by July 2008
  - Determine Rehabilitation Scope and Cost
    - September 2007
